Manhole Inspection Summary

Manhole # S09UU_010MH

Insp Date: **2/19/09 11:40 AM**

Location Address: **3200 HILTON ST**

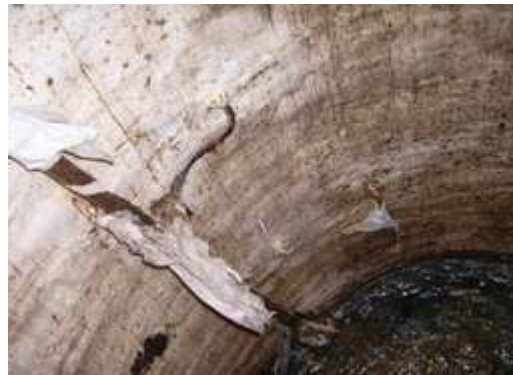
Defect 2

EVIDENCE SURCHARGE; CORRODED STEP

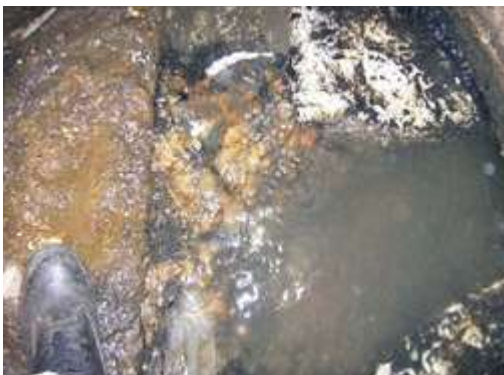
Defect 1

DEBRIS; ACTIVE SURCHARGE AT FIRST ATTEMPT

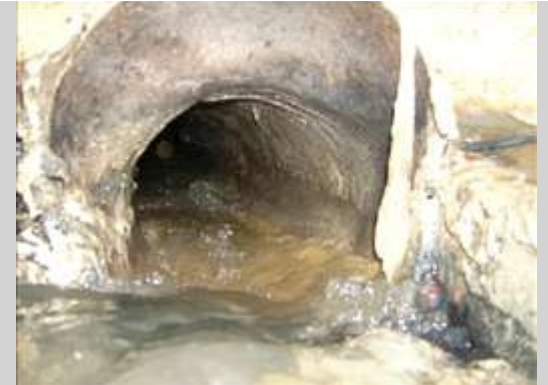
12 O'Clock Outflow

12 in. Circular Gravity Sewer
Pipe Out @ 12 O'Clock

Pipe Height: (in.) Direct
Pipe Material: **Clay** ☐ Pipe Lined
Invert Depth: **12.95** (ft.) Flow Characteristics: **Slow**
Deposits: ☐ None ☐ Mud ☒ **Sludge** ☐ Debris ☐ Grease
Silt Depth: **6** (in.) Deposits Extent: **Heavy**
Infiltration: **None** Pipe Seal Cond: **Sound**

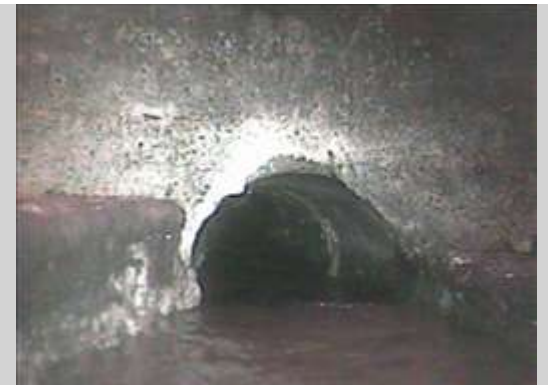
6 O'Clock Inflow

8 in. Circular Gravity Sewer
Pipe In @ 6 O'Clock

Pipe Height: (in.) Direct
Pipe Material: **Clay** ☐ Pipe Lined
Invert Depth: **12.88** (ft.) Flow Characteristics: **Slow**
Deposits: ☐ None ☐ Mud ☐ Sludge ☒ **Debris** ☒ **Grease**
Silt Depth: **6** (in.) Deposits Extent: **Heavy**
Infiltration: **None** Pipe Seal Cond: **Sound**
